FLIR MR160

Imaging Moisture Meter

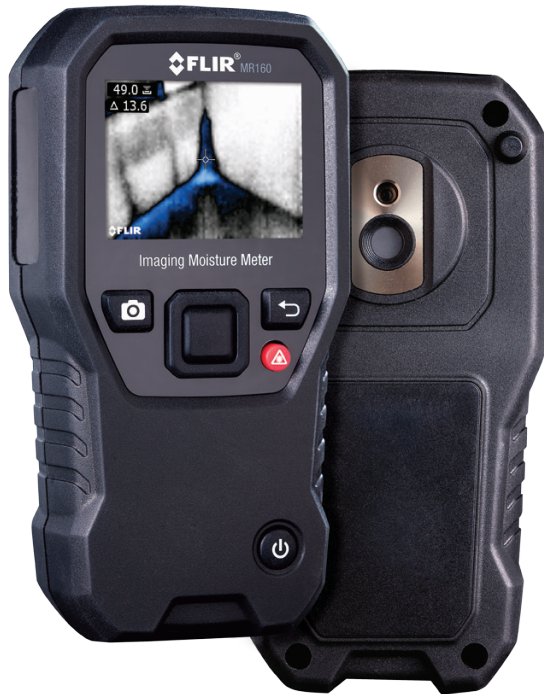
The FLIR MR160 Imaging Moisture Meter is the *first of its kind*. Equipped with a built-in thermal camera, MR160 is the *only* moisture meter with the power to show you exactly where to measure.

Featuring **Infrared Guided Measurement (IGM™)** technology, the MR160 helps you quickly scan and target moisture issues, visually guiding you to the spot where you can confidently take measurements and analyze readings.

An integrated pinless sensor and an external pin probe provide the flexibility to take either intrusive or non-intrusive measurements. Built tough with an industry-leading warranty, the MR160 can serve as your go-to troubleshooting tool right out of the box – or as the perfect complement to any high resolution thermal camera you already own – helping you find hidden moisture issues and capture reliable data more efficiently.

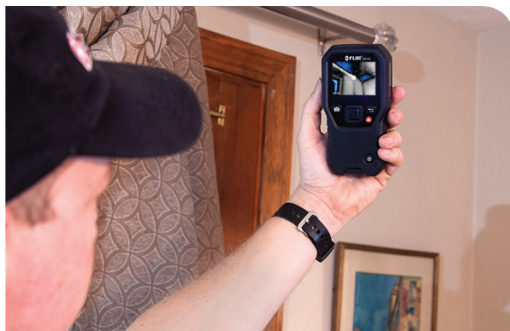
Scanning ceiling & wall joint for moisture issues

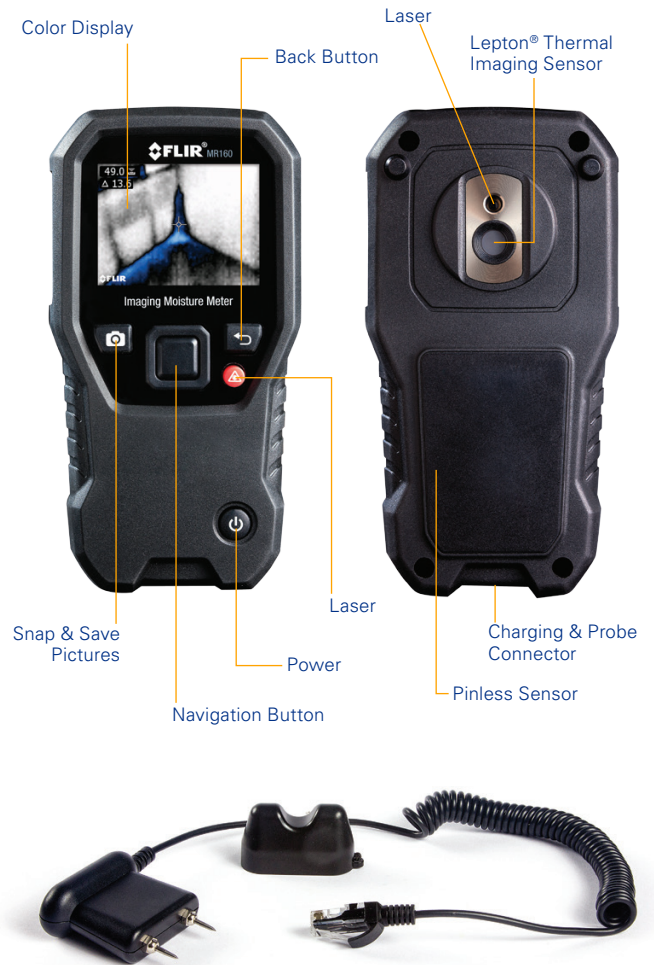
MR02 Pin Probe included
